# The Evaluation of High Molecular Weight Methacrylate as a Treatment Option for Shrinkage Cracks in Airfield Pavement

THESIS

Austin R. Hayes, Captain, USAF

AFIT-ENV-MS-19-M-177

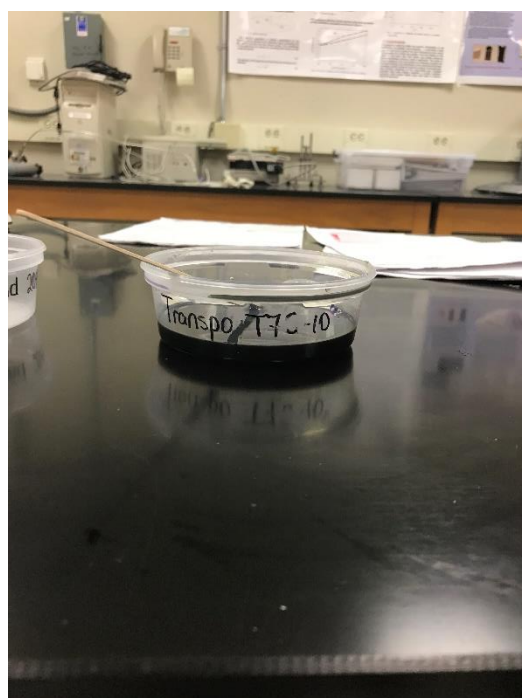
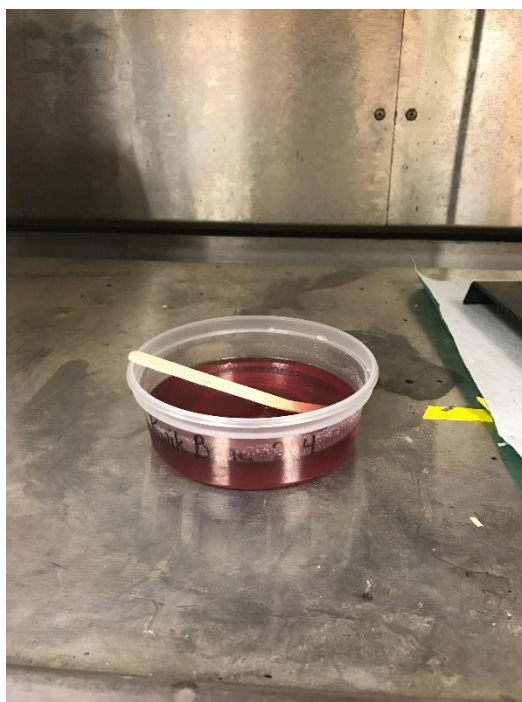
Figure 7. Gel Time Tests

Figure 8. Transpo T70 Gel Time Test

Figure 9. TK-2415 Gel Time Tests

Figure 10. Kwik Bond Gel Time Tests

Figure 11. TK-2110 Gel Time Test

Once the initial set of tests were completed, tests were completed to find the pot life of the material using small disposable containers (Figures 7 to 11). These tests were completed to find the time between the mixing of the initiator and monomer and the polymerization or hardening of the polymer. The pot life is a measure of the working time of the material. These first tests were accomplished on the TK-2415 HMWM by combining the neat monomer, initiator, and promoter using the ratios provided by the manufacturer in a disposable cup and mixing them together. For these tests, 50 mL of the neat monomer, 1.430 mL of the initiator, and 0.508 mL of the promoter were used. The measurements were taken using a graduated cylinder for the neat monomer and micro pipettes for the initiator and the promoter.

The promoter was added in and stirred for a minute, and then the initiator was added in and stirred for another minute. The measured time began once the initiator was introduced to the neat monomer. The material was stirred for five seconds every five minutes until it was noticed that the consistency became similar to Jell-O and could not flow down the container when tipped. The time was recorded at this point. The same procedure was used for the other three sealants using the following mix ratios.

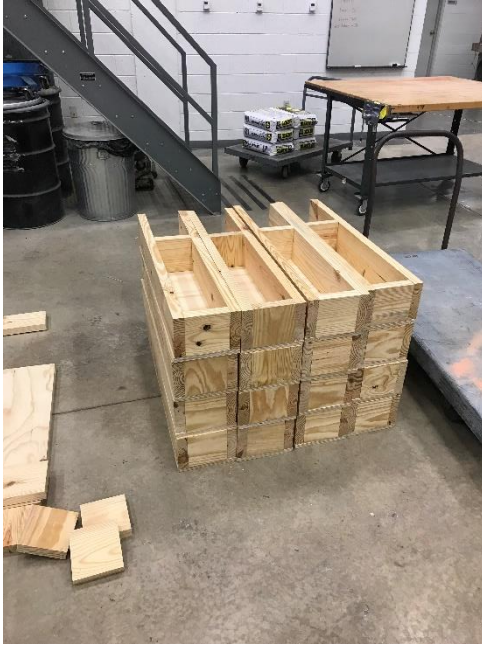
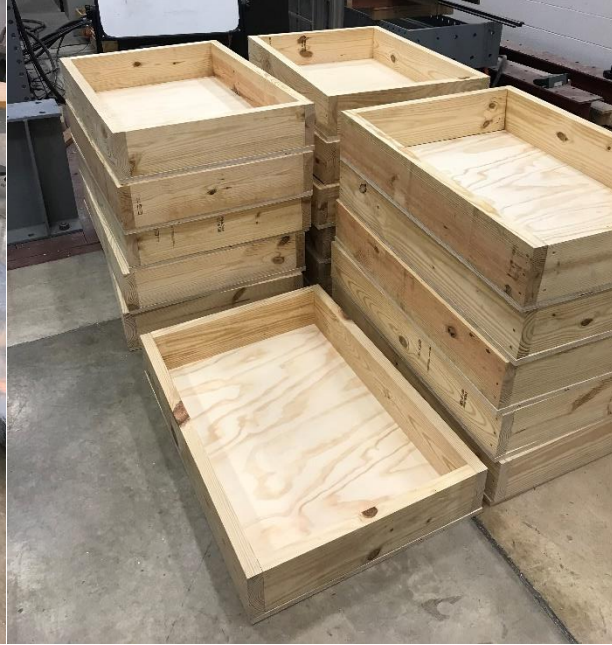
Figure 12. Beam Specimen Forms

Figure 13. Slab Specimen Forms

specimens measuring 15.2cm x 15.2cm x 61cm and the slab specimens measuring 15.2cm x 61cm x 91.4cm. Wooden forms were constructed using 2x8s (Figures 12 and 13) and placed on a sheet of plywood over a large piece of plastic. The 2x8s were cut to a width of six inches to produce slabs six inches thick.

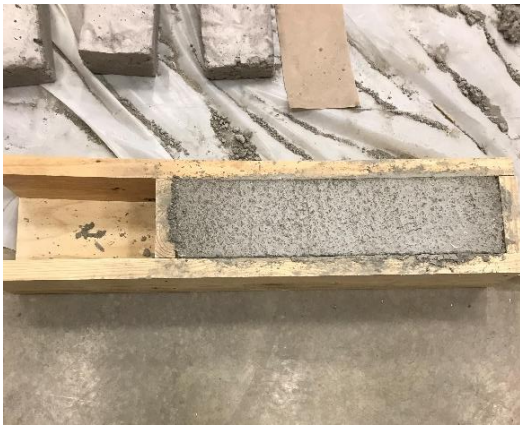
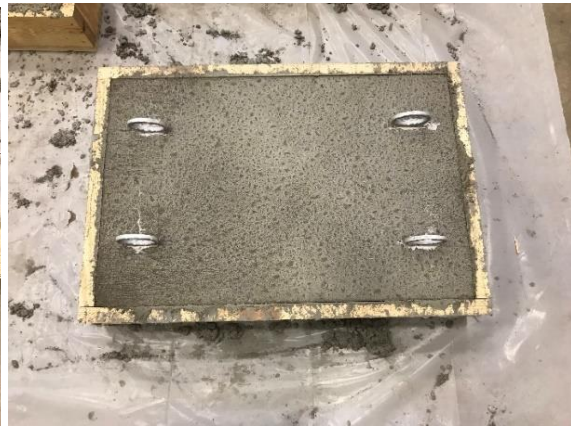
Figure 14. Finished Beam Specimen

Figure 15. Finished Slab Specimen

shoveled into the forms until the concrete reached the top. For the slabs, the concrete was shoveled into the forms until the concrete reached the top (Figure 15). The slab specimens were then vibrated and finished with a hand trowel. The slabs had four handles with rebar placed into the concrete between the two handles on each side before finishing.

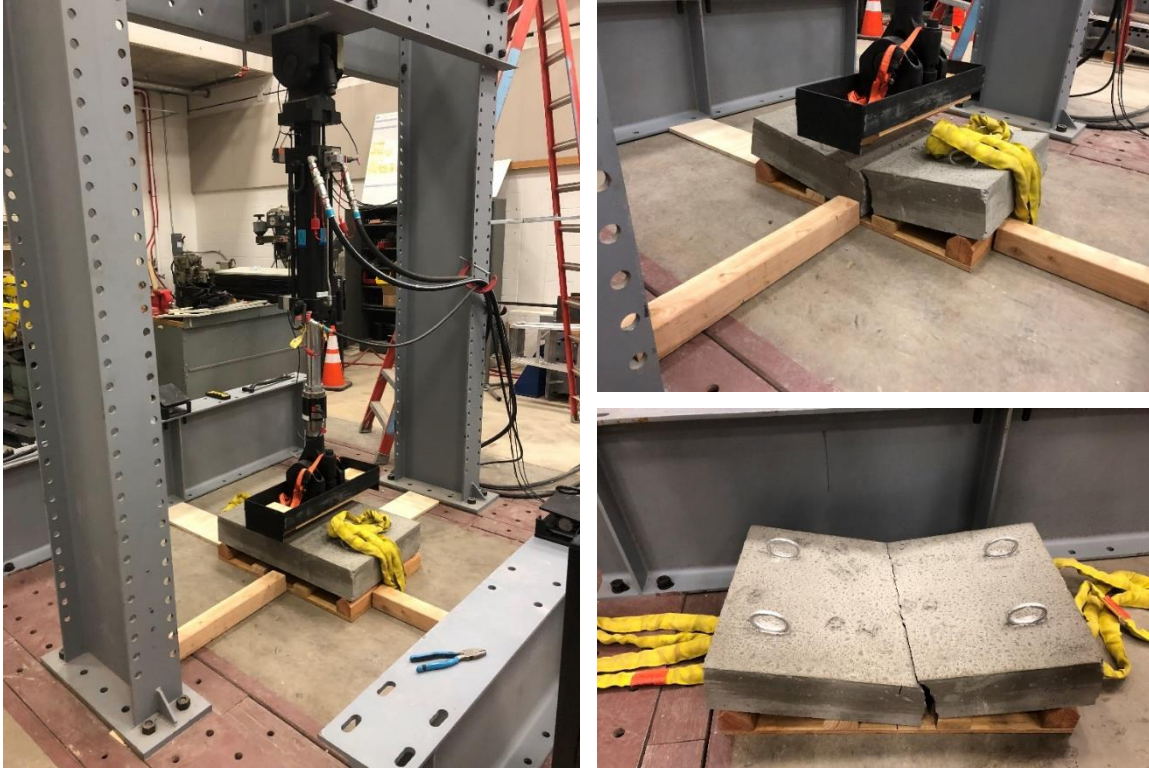
Figure 16. Breaking of Slab Specimen

After 64 days, the forms were taken apart and the specimens were broken in half. The beam specimens were pulled apart since they had the Teflon in the center, while the slab specimens were broken using a large hydraulic press. The slab specimens were placed on a wooden pallet under the press where a load was applied to the middle of the specimens until they cracked all the way through (Figure 16). Once the specimen was broken, it was removed and set to the side.

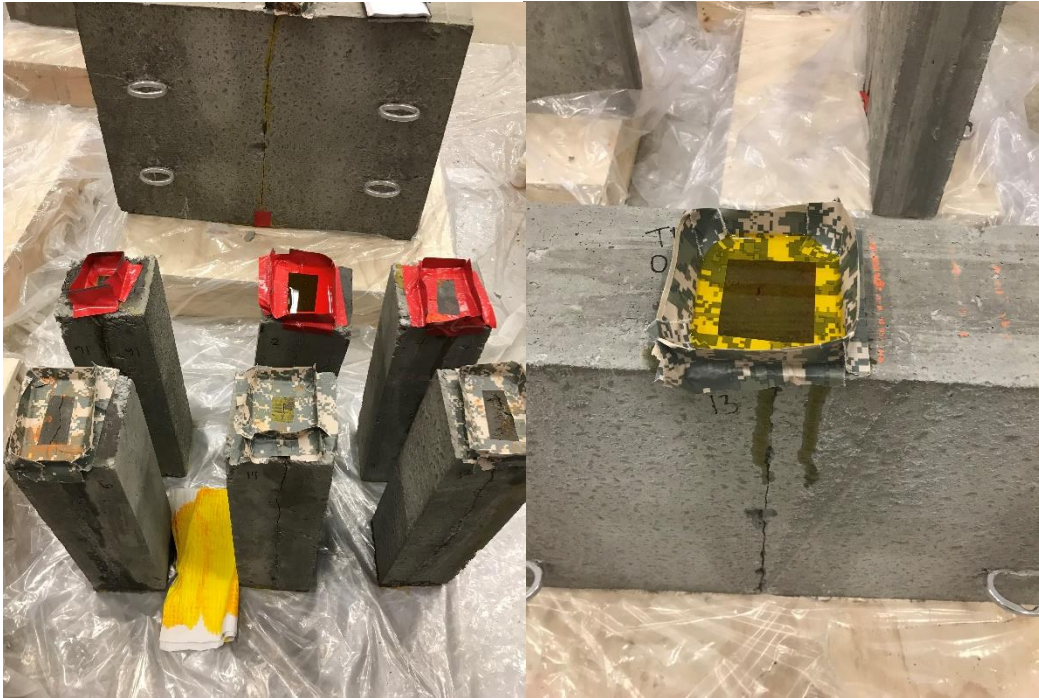
Figure 17. Ponding Tests

Once the specimens were tested, duct tape was used to make a small reservoir over the cracks to contain a small amount of water such that the water would seep into the cracks. This ensured that if there was a loss of water, it was due to it flowing through the crack and not over the sides of the specimen. A mixture of ½ tablespoon of Keda Dye powder and 177 mL of water was stirred until the powder were mixed fully into the water (Figure 17). The dyed water was then poured over the cracks; if the water immediately drained into the crack, no more water was poured. If the water did not drain, a sufficient amount of water was poured into the reservoir until there was adequate water over the

crack. The water was allowed to sit for 15 hours; if there was any water left, it was cleaned up with absorbent pads.
